home inspection services, llc

Inspection Report

Property Address:
1515 Mockingbird Ln.
Milwaukee WI 53601

Date: 6/30/2011	Time: 2:02:00 PM	Report ID: 0923101
Property: 1515 Mockingbird Ln. Milwaukee WI 53601	Customer: John Doe	Real Estate Professional:

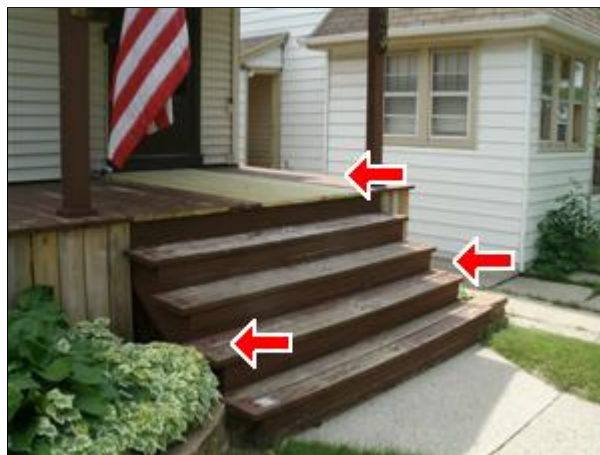
(1) There are some missing railings present on the porch on the north side of home.

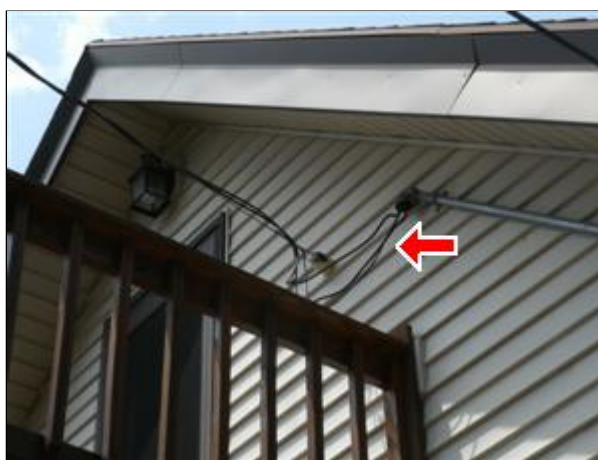
The electrical service conductors clearance from the deck is lower than 10 feet, recommend correcting for safety. Recommend qualified electrical contractor for further evaluation.

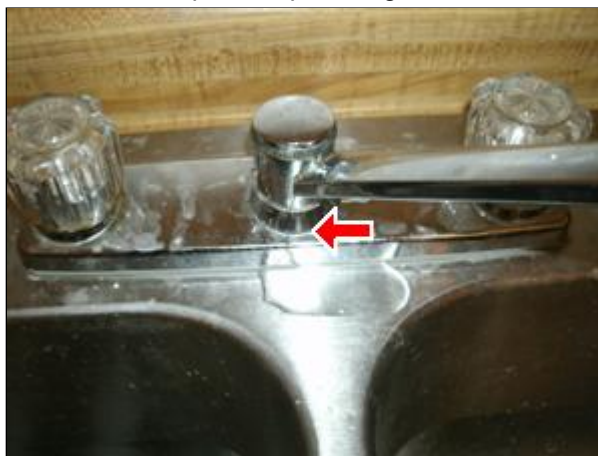
The faucet leaks around the spout. Recommend qualified plumbing contractor for further evaluation.

- The faucet leaks around the spout. Recommend qualified plumbing contractor for further evaluation.

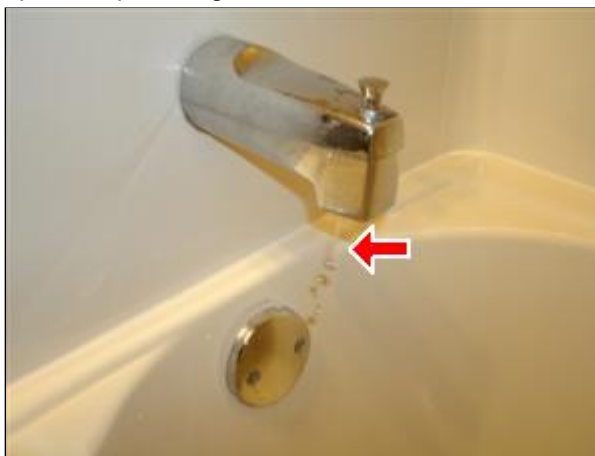
(2) The faucet drips. Recommend qualified plumbing contractor for further evaluation.

- (2) The faucet drips. Recommend qualified plumbing contractor for further evaluation.
